Manhole Inspection Summary

Manhole # S65G__004MH

Insp Date: **3/14/08 10:22 AM**

Location Address: **400 El Rino St.**

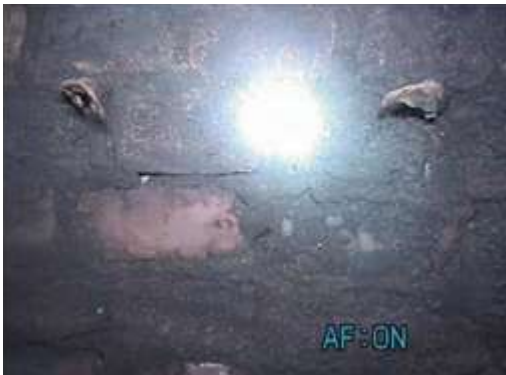
Defect 1

Steps Count: **0** Missing: **3** ☒ **Corroded**

missing step

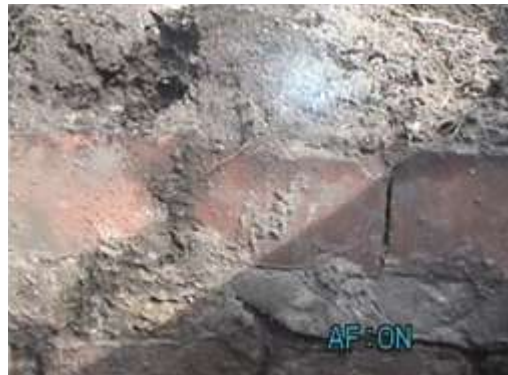
Defect 2

Frame Offset: **4** (in.) Condition: ☐ Sound ☒ **Cracked** ☐ Leaks

Condition: ☐ Sound ☐ Cracked ☐ Root Intrusion ☒ **Loose Brick** ☒ **Deteriorated**

Infiltration: ☐ None ☒ **Joint** ☒ **Cracks** ☒ **Mortar** ☐ Roots ☐ Wall

Signs of infiltration in chimney/offset.

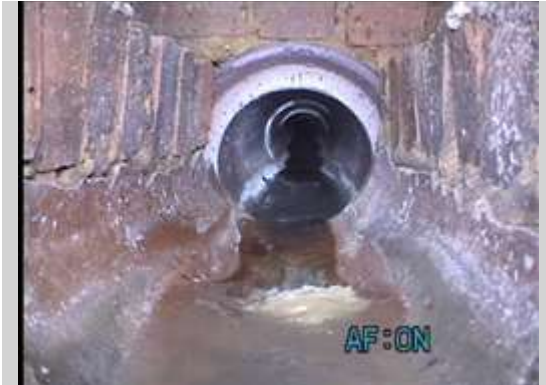
12 O'Clock Outflow

8 in. Circular Gravity Sewer
Pipe Out @ 12 O'Clock

Pipe Height: **8.4** (in.) Rod and Bar (Angled)
Pipe Material: **Clay** ☐ Pipe Lined
Invert Depth: **8.00** (ft.) Flow Characteristics: **Slow**
Deposits: ☒ None ☐ Mud ☐ Sludge ☐ Debris ☐ Grease
Silt Depth: (in.) Deposits Extent:
Infiltration: **None** Pipe Seal Cond: **Sound**

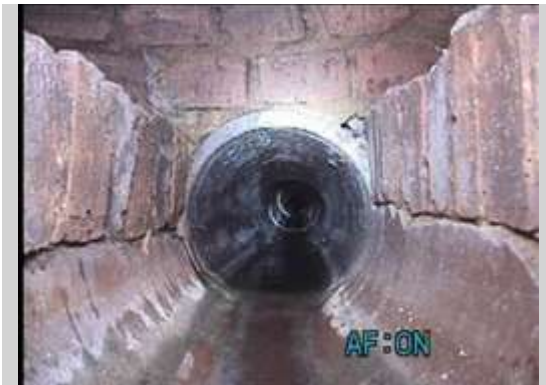
6 O'Clock Inflow

8 in. Circular Gravity Sewer
Pipe In @ 6 O'Clock

Pipe Height: **8.4** (in.) Rod and Bar (Angled)
Pipe Material: **Clay** ☐ Pipe Lined
Invert Depth: **7.96** (ft.) Flow Characteristics: **Slow**
Deposits: ☒ None ☐ Mud ☐ Sludge ☐ Debris ☐ Grease
Silt Depth: (in.) Deposits Extent:
Infiltration: **None** Pipe Seal Cond: **Sound**
